Report Index

FILE #:	ACL031905.
DATE/TIME OF INSPECTION:	3/19/05 9:00AM.
CLIENT NAME:	Jason Smith.
MAILING ADDRESS:	61 Rounds Road Redding Ct.
PHONE NUMBERS:	802-769-1234.
INSPECTION LOCATION:	1 Doccert St. Anytown USA.

ESTIMATED AGE OF HOUSE:	1971.
BUILDING TYPE:	1 Family, Ranch.
STORIES:	1.
SPACE BELOW GRADE:	Basement.

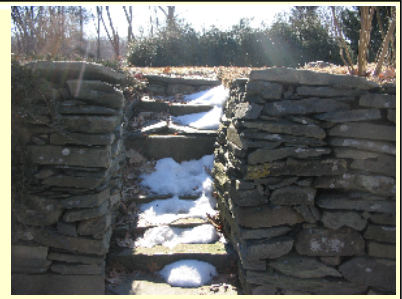
EXTERIOR STAIRS/STOOPS:

Concrete, The stoop(s) is in acceptable condition. Stone Steps are present in the rear- Loose step(s) noted. Recommend repairing to avoid a trip hazard. Recommend installation of handrail for safety. Where 3 risers are present a side railing is required. Improper rise or run noted on the exterior steps. Recommend adjusting for safety.

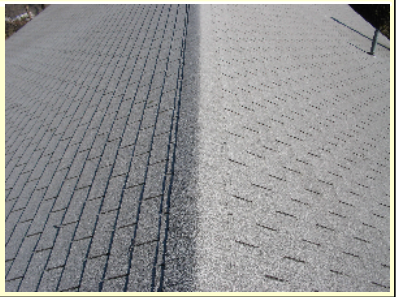
ROOF TYPE #1:

A Composition shingle roof is present. (18-20 shingle design life)

Unable to verify the presence of an ice shield under the roof covering. Ice shields or "eave protection" is not required but installation helps protect the lower roof sections from the winter conditions of the northeast. Mold and/or mildew noted to the roof surface.

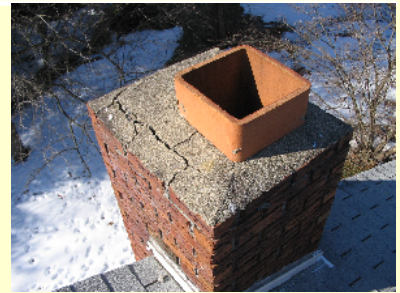
CHIMNEY TYPE #1:

Recommend cleaning and evaluation by a chimney expert prior to closing. Chimneys and flue liner, if present, are not fully accessible due to finished surfaces and in most cases require special cameras for inspections. Deterioration noted to crown area. Recommend repairing the crown area to aid in preventing water and ice from accumulating around the liner and eventually find its way into the chimney. Recommend installing a spark arrestor cap.

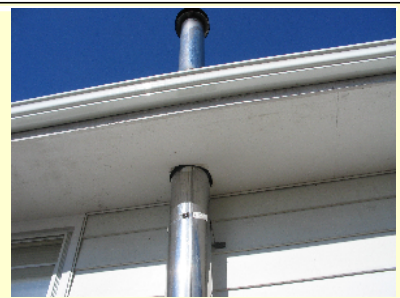
CHIMNEY TYPE #2 :

Metal with no chase(exposed metal). Recommend installation of approved firestop material around chimney where it goes through soffit.

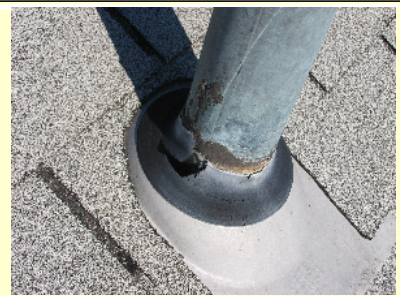
PLUMBING VENTS:

Damage and/or cracking noted to the plumbing vent boot. Repairs recommended at this time.

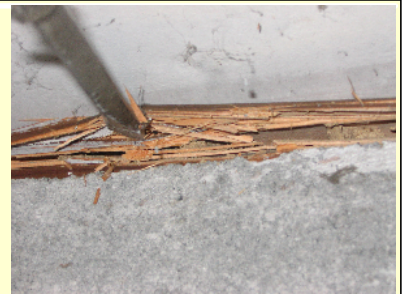
SILL PLATE:

The sill plate is damaged and will require repairs. Recommend further evaluation and repairs by a contractor.

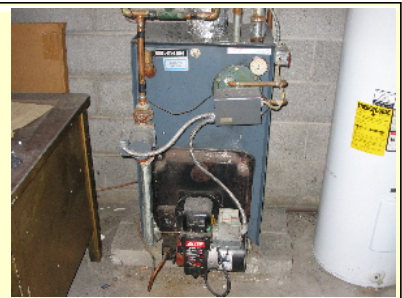
SYSTEM TYPE/LOCATION:

Oil fired, Hydronic Boiler The heating system is located in the garage.

Rust noted on the circulating pump. The pump was not leaking at the time of the inspection and was functional.(water was circulating). This situation should be monitored over time or have the unit replaced to prevent damage.

Poor slope noted on the heating system vent connector. The vent connector should slope upward going away from the unit at a minimum of 1/4 inch per foot. Improper slope can allow exhaust spillage into the house and/or condensation may collect in the vent connector system. This can damage the vent connector. Recommend evaluation and repairs by a licensed heating contractor. Barometric damper was not functioning properly during operation. Spillage can occur at the barometric damper. Recommend evaluation and repairs.

Signs of flame rollout noted on the heating unit cabinet. Flame rollout occurs when the flame backs out of the combustion chamber on start-up of the burner. This can be caused by over firing, blocked ventign system or lack of a secondary air. This can start a fire, and the wiring and burner controls can be damaged. Recommend repairs by a heating technician.

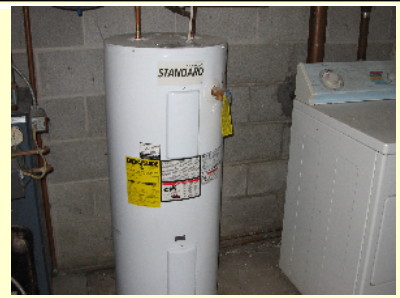
LOCATION AND SIZE:

The hot water heater is located in the garage. A 40 gallon tank was present at the time of the inspection.

Missing or reduced extension tube on relief valve noted. The relief valve tube has to extend down to a safe location, typically 6 to 12 inches above the floor. This minimizes the chance of spraying anyone with scalding hot water. This is a minor repair.

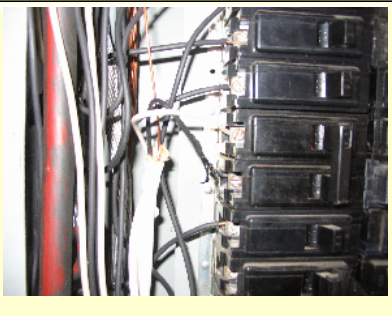
PANEL BOXES:

Circuit breakers are present. Overheated wire noted on 30 amp breaker. This wire is undersized, recommend immediate repairs by an electrician. This is a fire hazard. Open knockouts noted in the panel box. Recommend covering to avoid contact with wires. Improperly wired subpanel noted. The neutral and ground wires are bonded. This is not allowed. Recommend further evaluation and repairs by an electrician. Recommend further evaluation by a licensed electrician.
